Condition Assessment
&
Reserve Fund Plan Update
2020

Laurel Mews

Arlington, Virginia

RE: **CONDITION ASSESSMENT AND RESERVE FUND PLAN UPDATE 2020**
Laurel Mews Homeowners Association
Arlington, Virginia
Project No. 8971

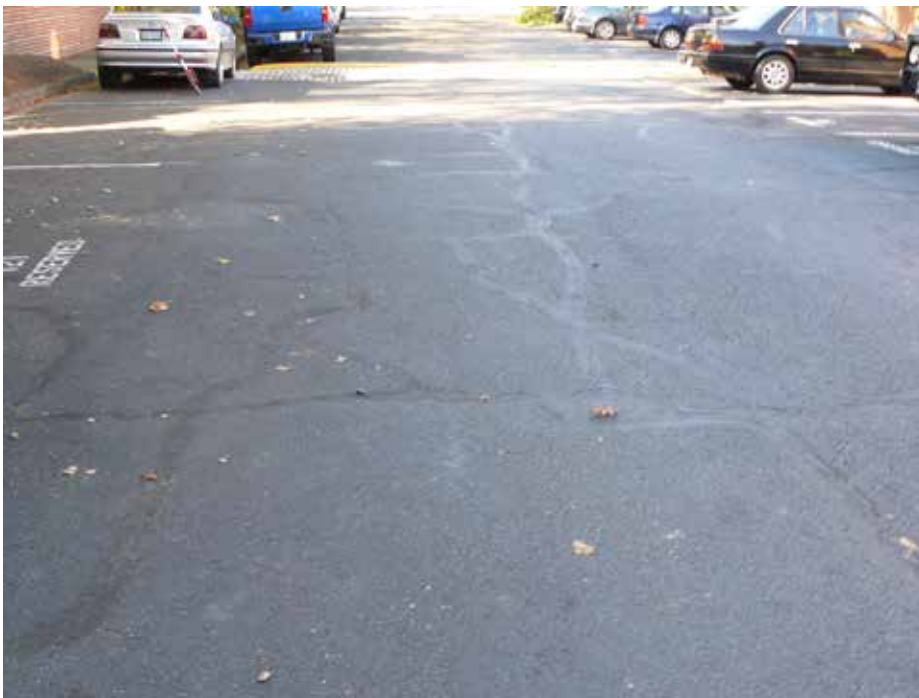
PHOTO #1
The asphalt driveways and parking bays are in fair condition. The pavements will require restoration (full-width profile milling and new compacted asphalt) in about five years.

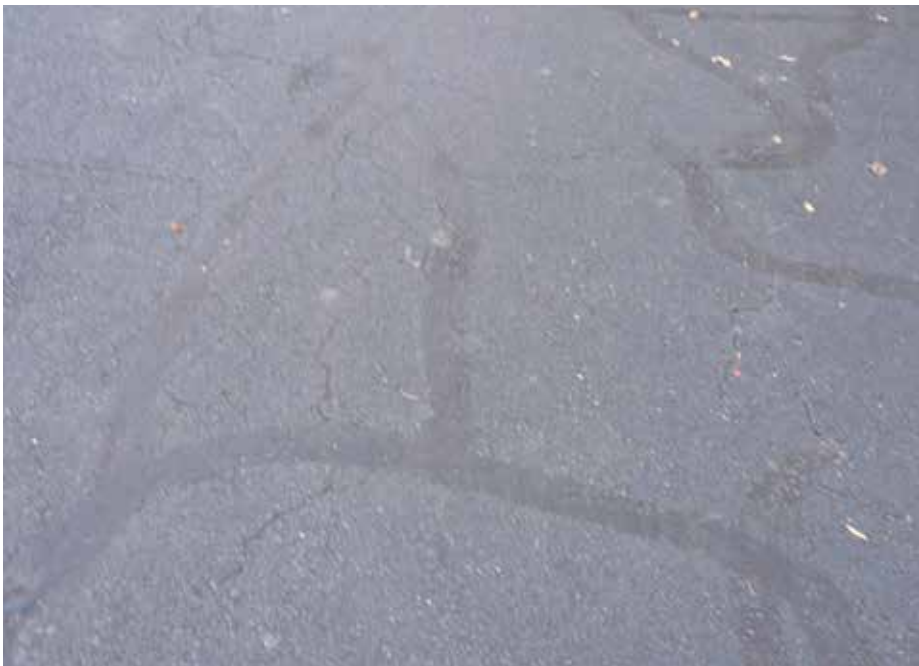
PHOTO #2
Some older cracking was filled, and the pavements were seal coated circa 2018. Continued pavement maintenance should be completed every five years, after the restoration project is completed.

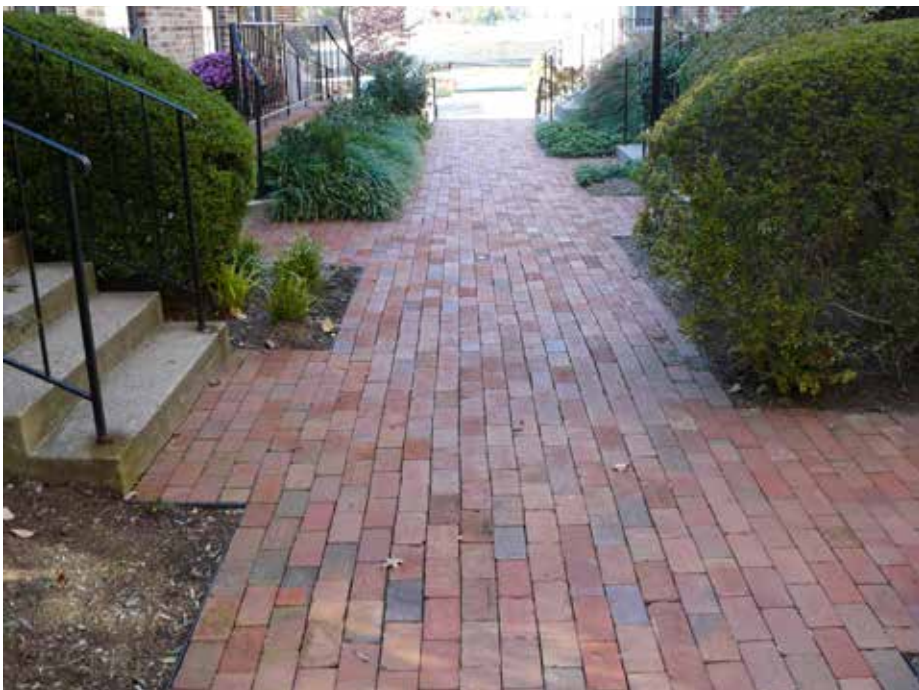
PHOTO #3
The brick sidewalks are in continuing good condition. No major deficiencies were observed. Any future tripping hazards should be mitigated to prevent personal injury.

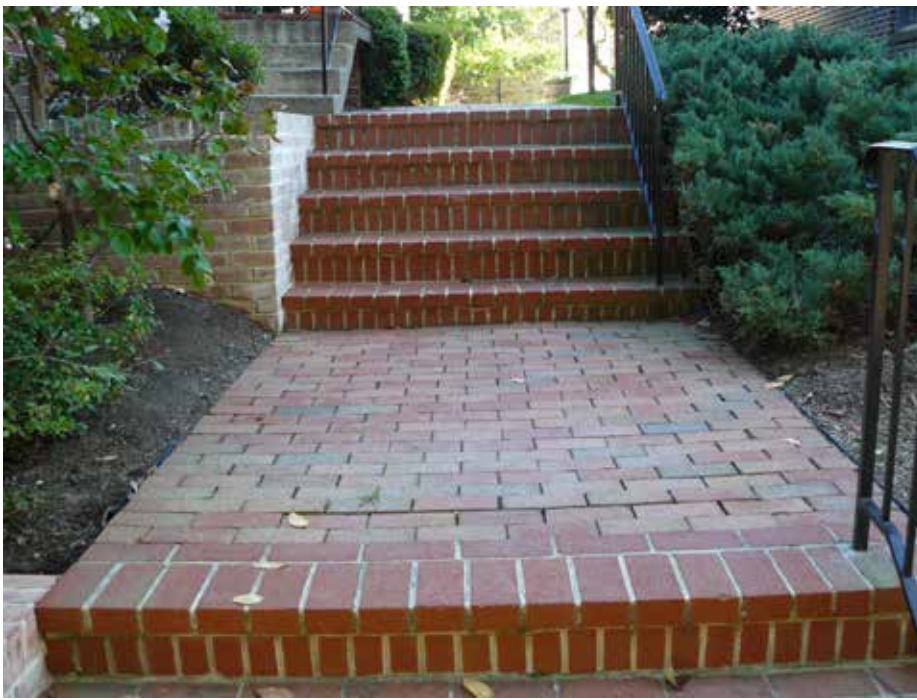
PHOTO #4
The brick and mortar steps are in continuing good condition.

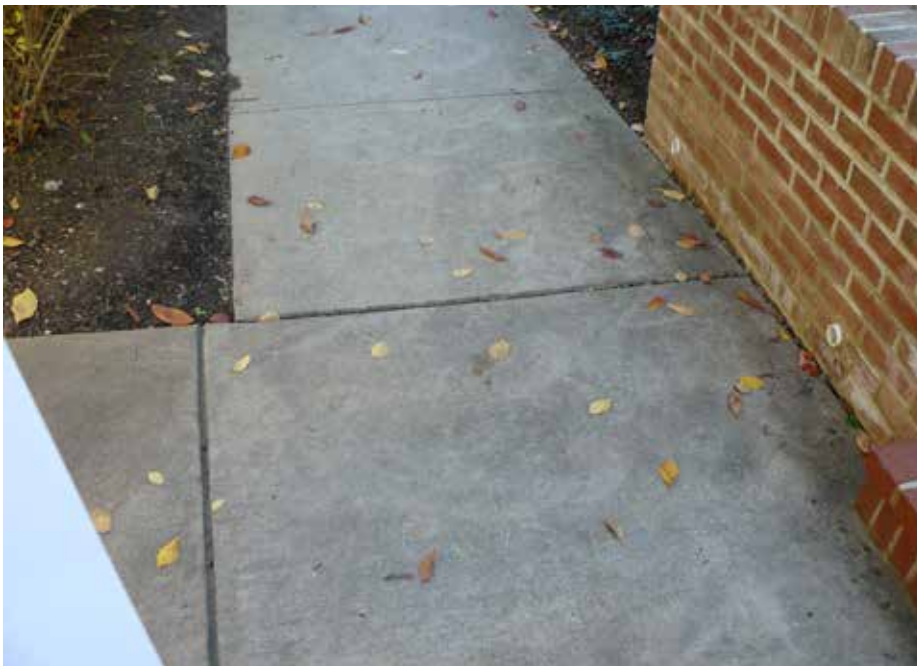
PHOTO #5
The concrete sidewalk panels are in continuing good condition, as it appears that a significant portion of concrete was replaced in recent years.

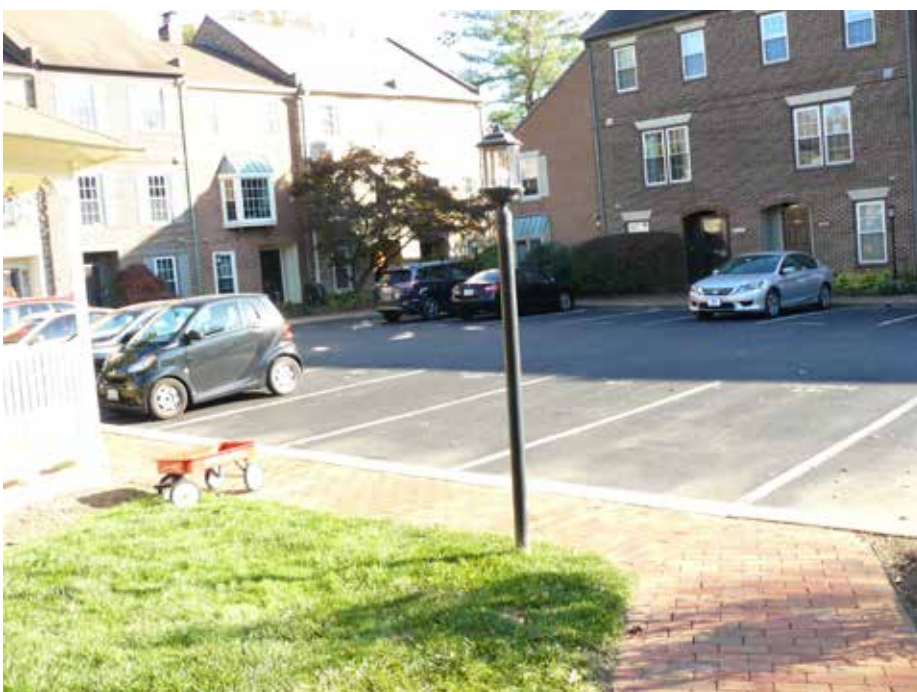
PHOTO #6
The area lighting and the light poles and fixtures appear to be in continuing good condition. Lighting was not observed after dark.

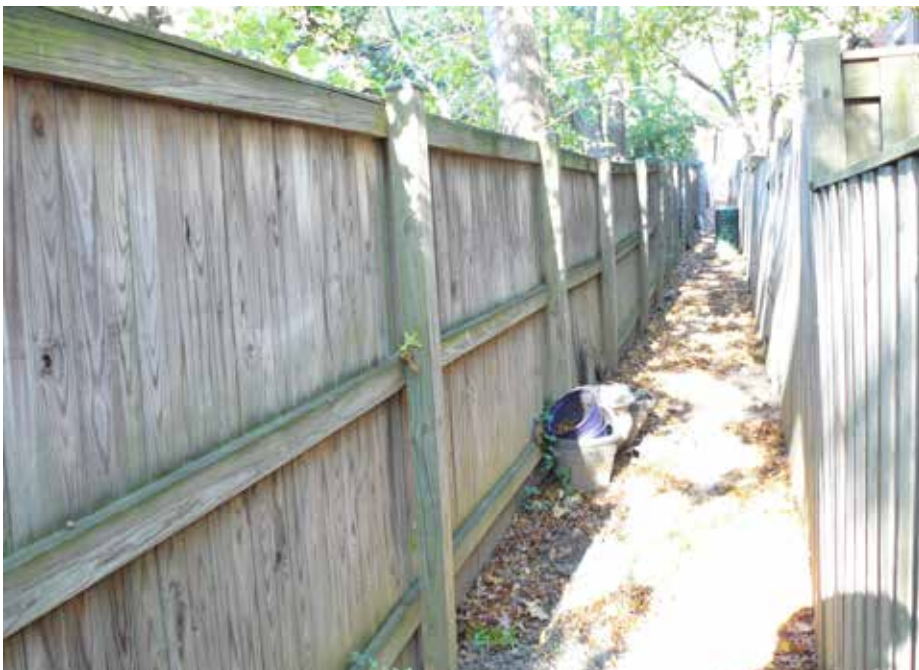
PHOTO #7
The pressure-treated wood fencing ranges from fair to continuing good condition.

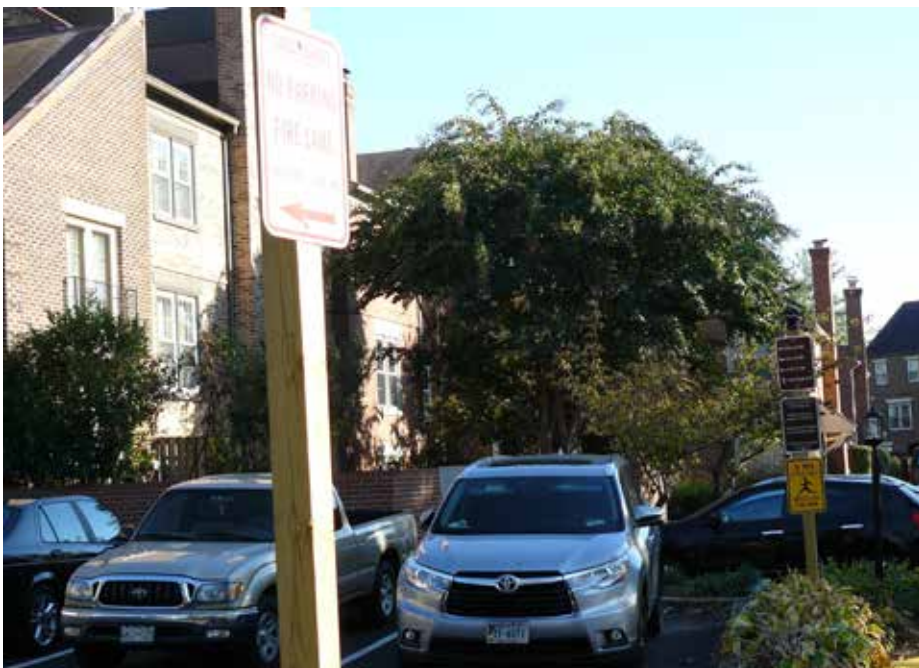
PHOTO #8
Street and informational signage has been recently replaced and is in continuing good condition.

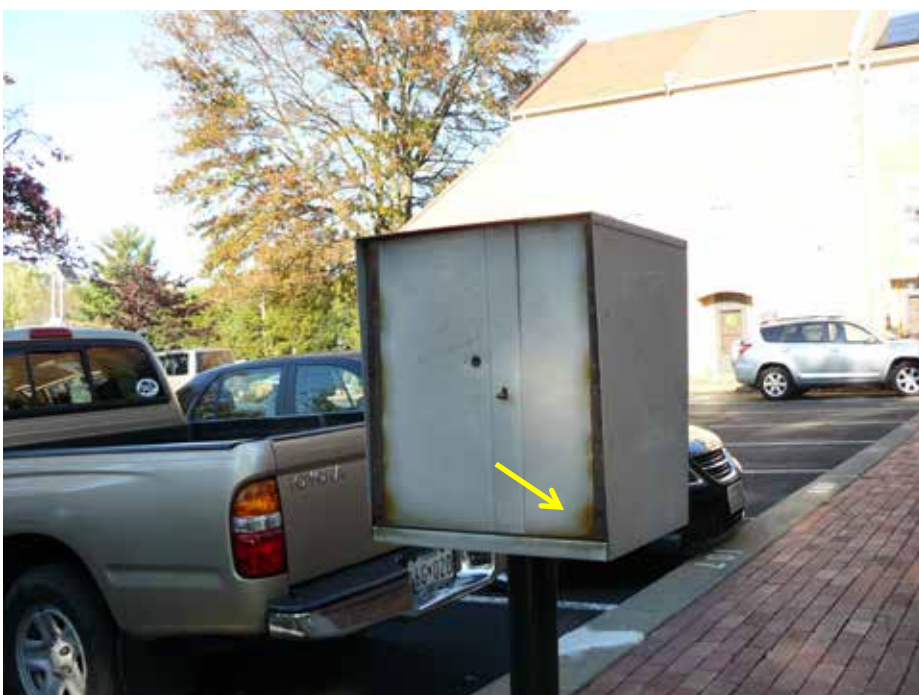
PHOTO #9
The mailbox modules are in fair condition. Some areas of rust were observed. Painting the modules may help to maximize their service life.

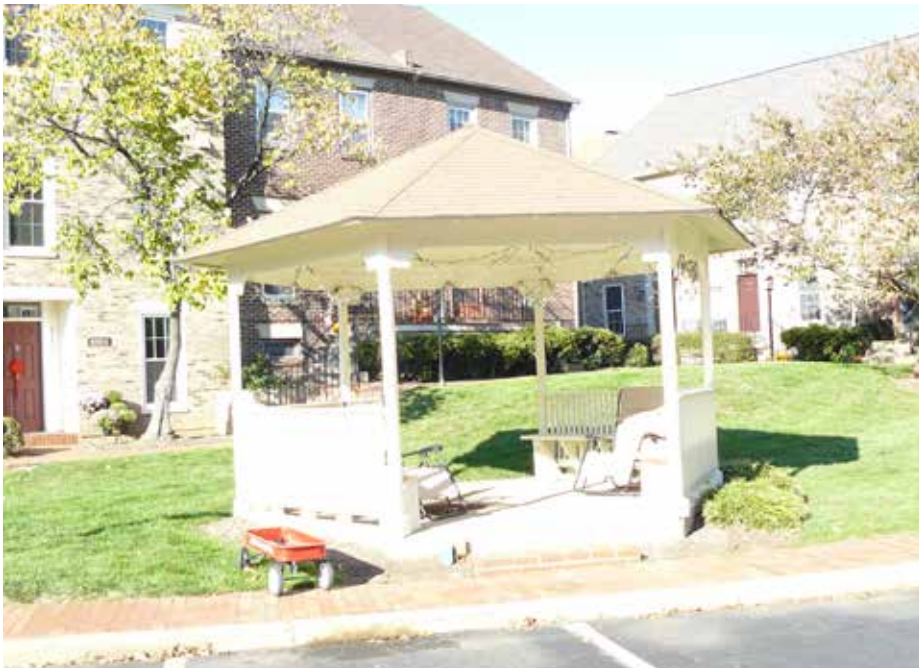
PHOTO #10
The gazebo appears to be in continuing good condition.

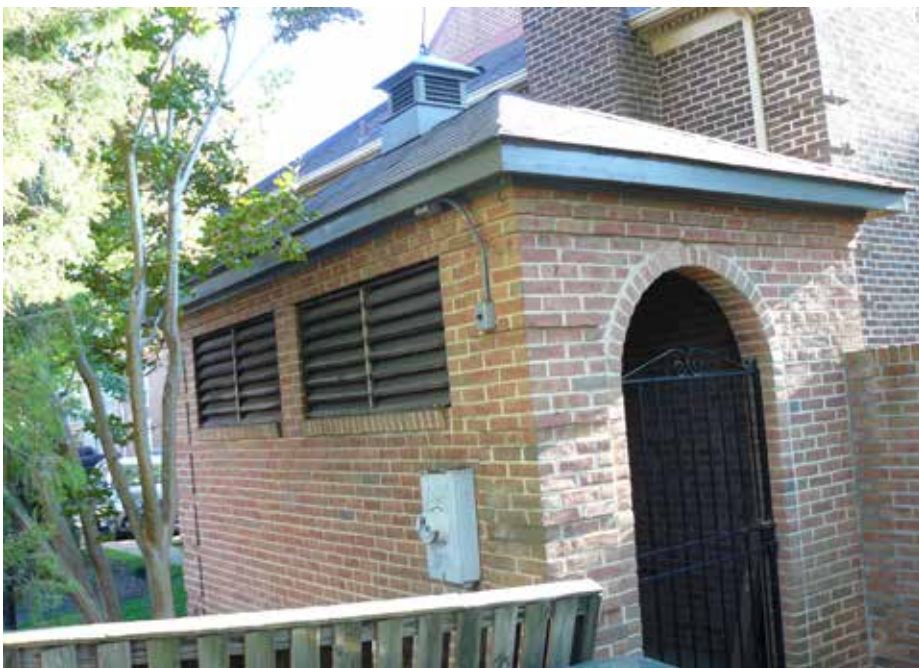
PHOTO #11
The shed areas appear to be in fair to continuing good condition. Some of the roofing may require restoration in the next five to six years.

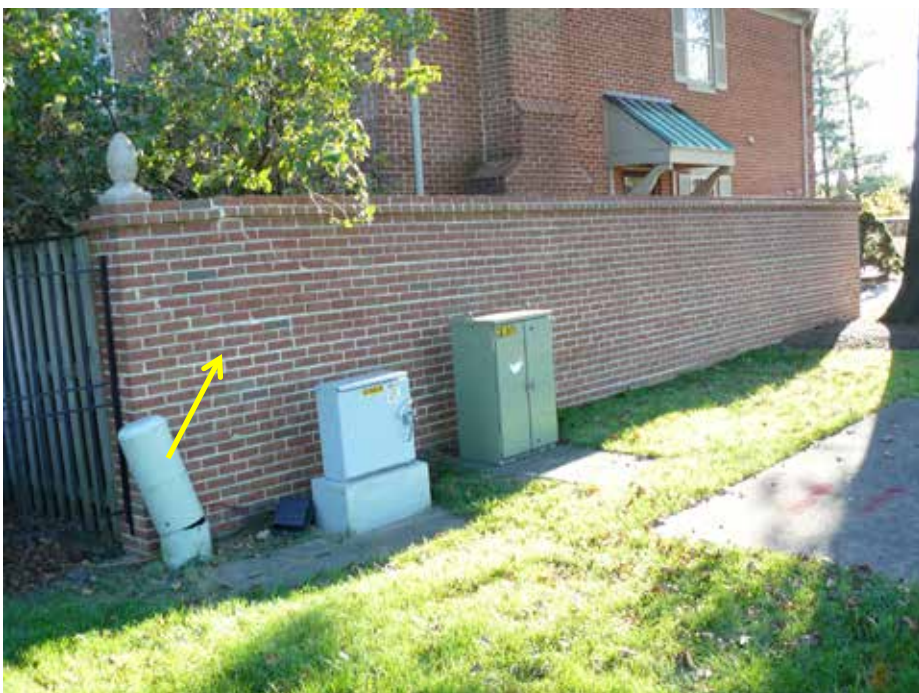
PHOTO #12
Tuckpointing repairs were made to most of the walls throughout the community, which will help to extend the walls service life.

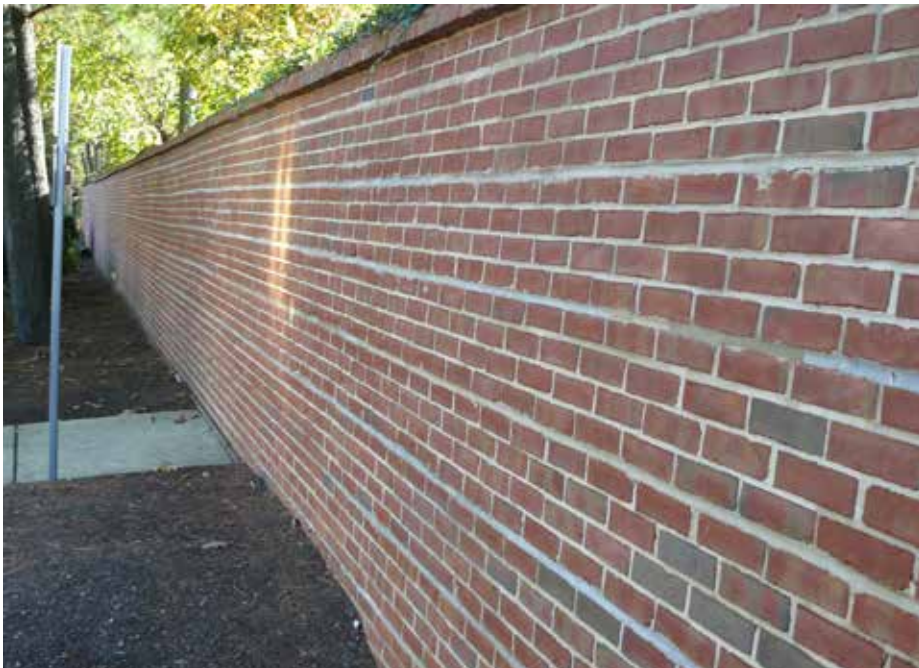
PHOTO #13
The largest of the brick walls, which separates the community from the Exxon station next door was tuckpointed on one side by the community.

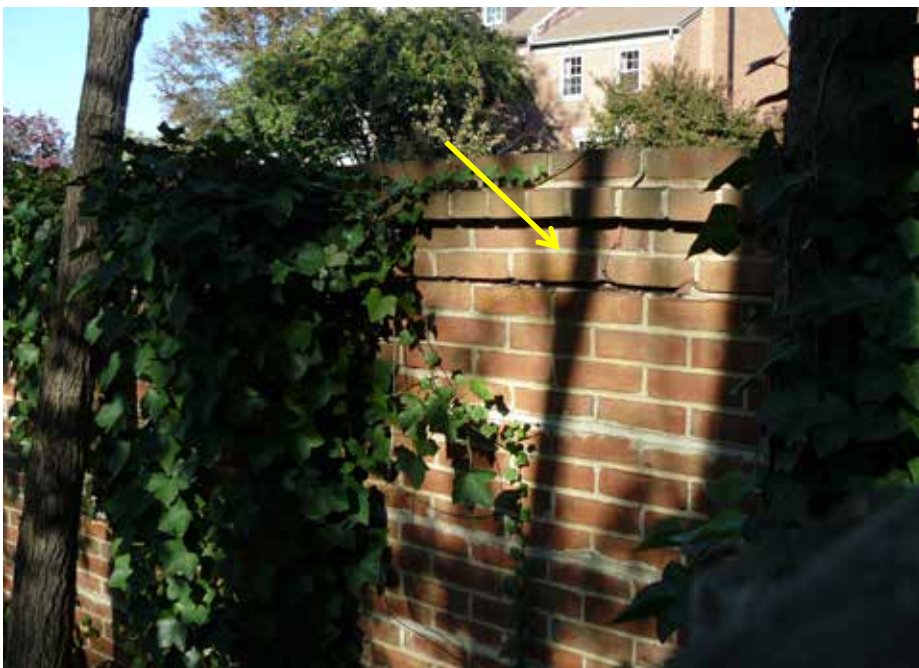
Most of the major common brick and mortar walls were recently restored throughout the community and are in much improved condition. The main wall, which separates the community from the neighboring Exxon station was also restored, but on only one side of the wall was fully repaired. The wall appears to continue to deflect towards the gas station side. It does not appear that the opposite side of the wall was restored. This wall may require full restoration in the future, for which we have scheduled in about ten years.

PHOTO #14
However, the back side of the wall is in poor condition and was not repaired.

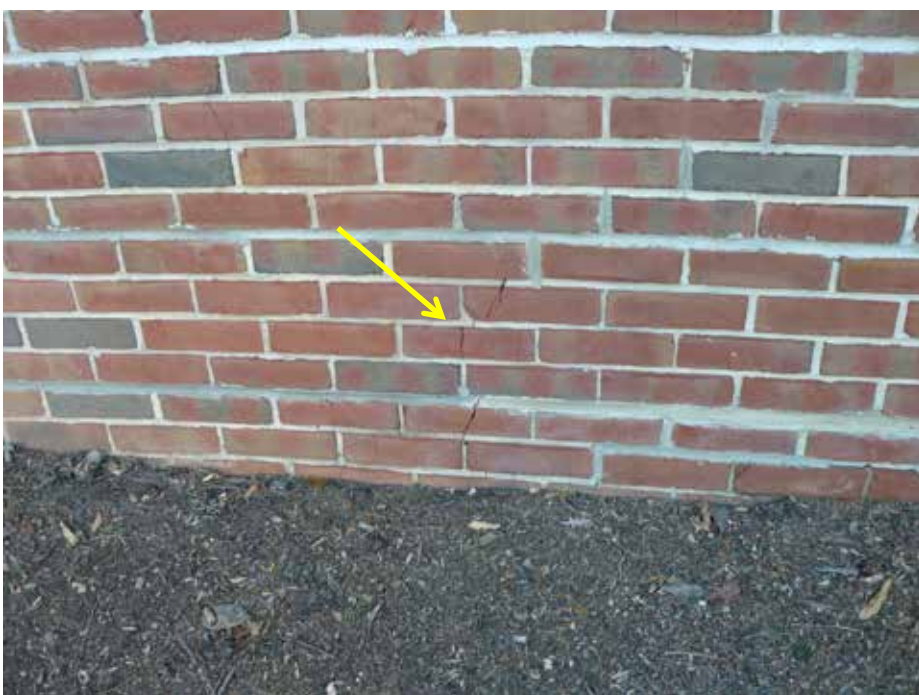
PHOTO #15
Continued cracking and possible structure failure will continue over the years, which may eventually require an entire wall rebuild.
